Reduce down time and increase reliability with a bobbin splice tail strip extraction

Suitable for SE ITM8000/SE Protos 80

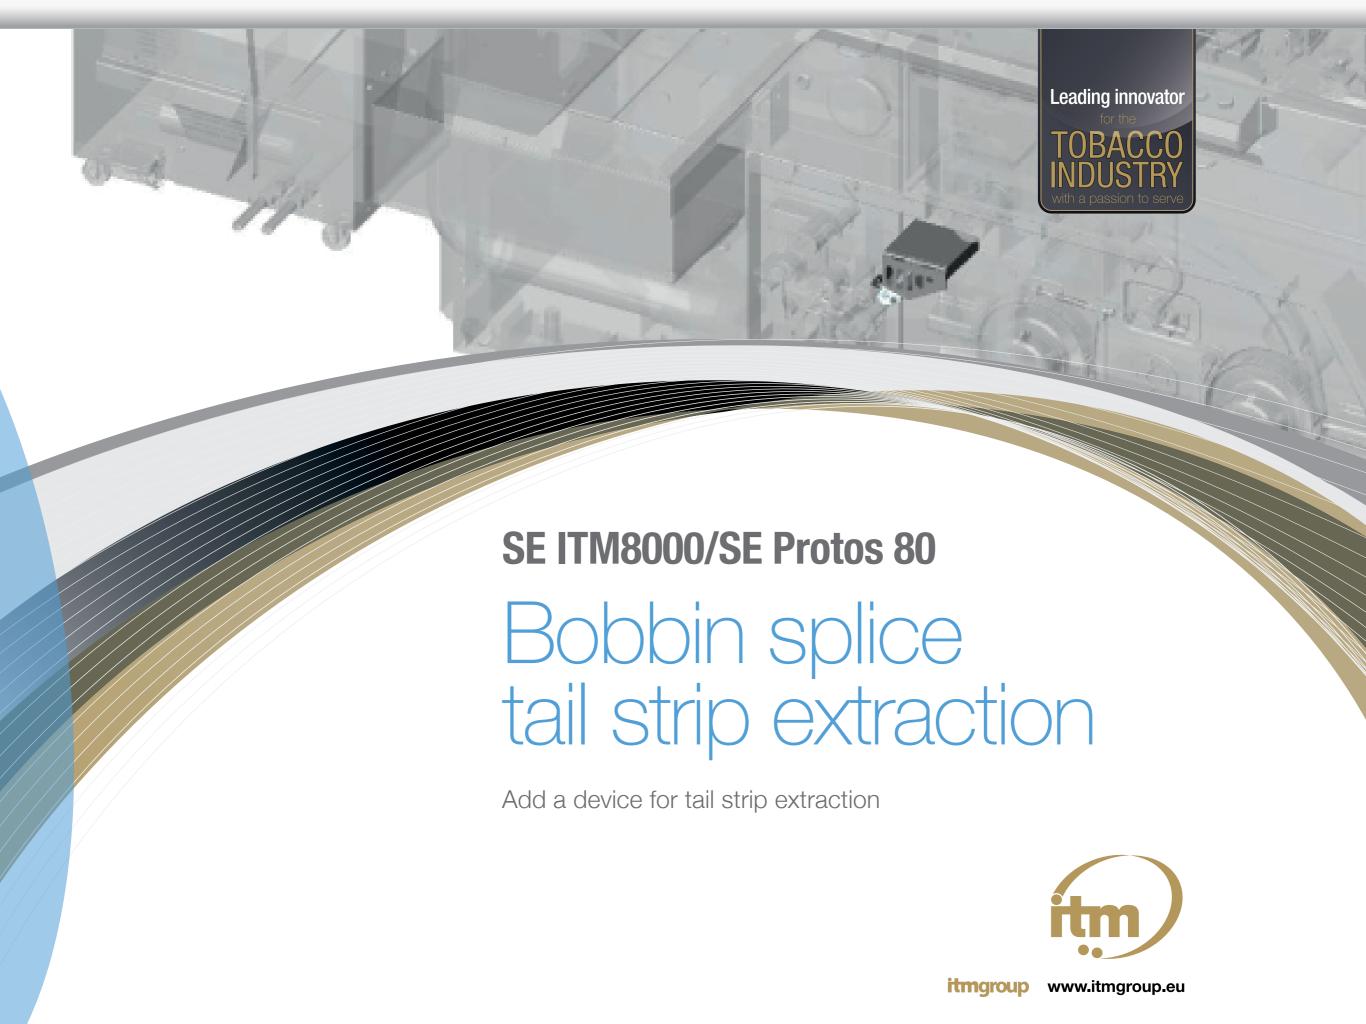
• The tail strip on the depleting bobbin is being drawn into the splicer and gets stuck in the splicer photo sensor

Malfunctioning during the splicing operation

Paper breaks

Retrofit kit to convert to tail strip extraction

The tail strip on the depleting bobbin is extracted after it
has been cut off - preventing a malfunction during the splicing process
