## Sasib 5000 Label unit update

## Reduce the frequency of label jams with a label unit update

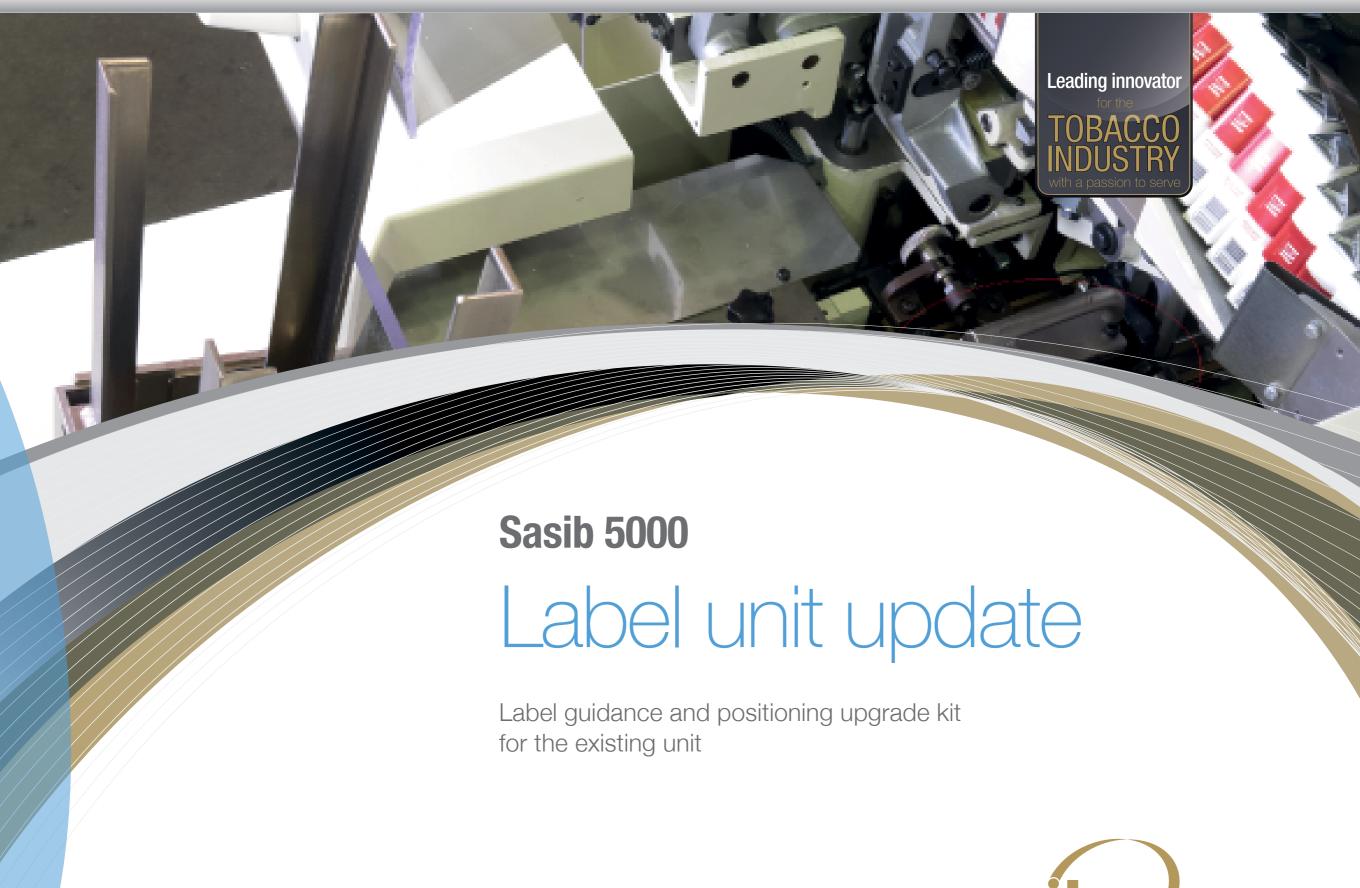
- Label jam caused by friction between the label and label guides
- Incorrect position of the label at the turret location

- Loss of production
- Down time
- Damaged parcels/cigarettes

- Label guide rollers and label positioning drive
- Label guides supplied with rollers for less friction during transport
- Label positioning at turret location for correct position of the label before transfer to turret

Complete kit to upgrade existing label unit
