GD4350 Elastic lever under folder

Reduce machine down time and the risk of machine damage with an elastic lever under folder

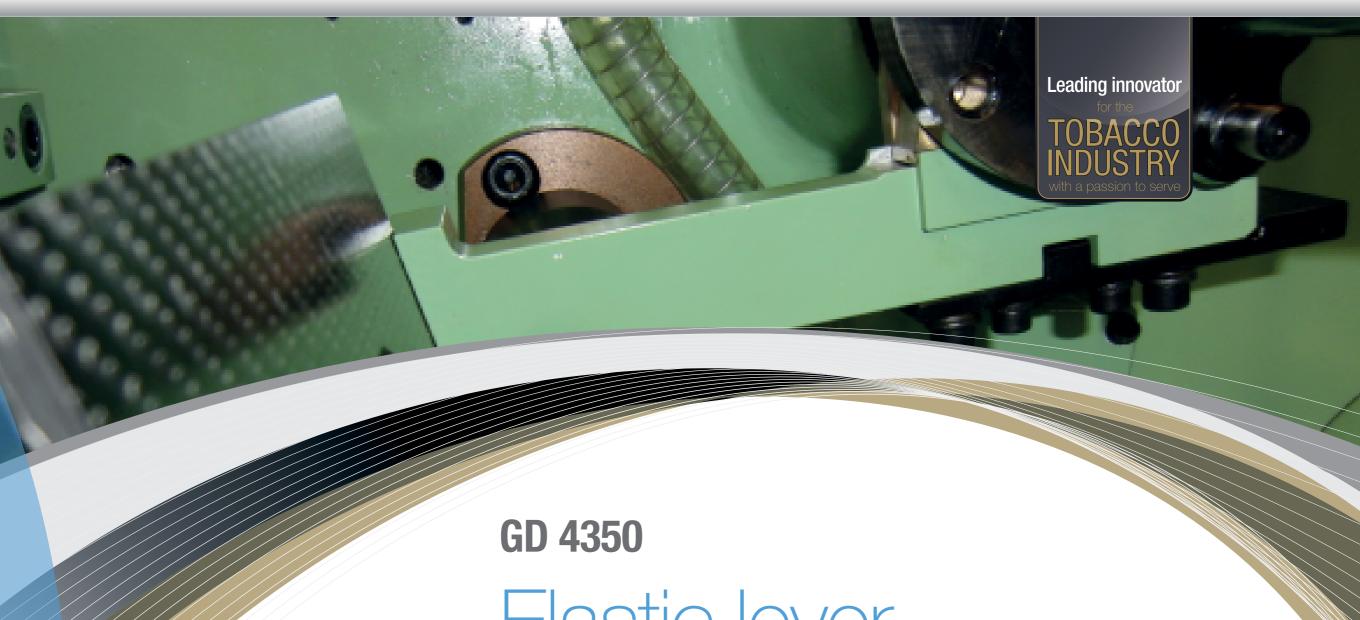
Elastic lever under folder

Elastic lever blank carriage which trips on overload, stopping the machine immediately

Issue

Risk of machine damage

Sensor causes immediate stop after jam

Spring-loaded arm to prevent excessive load on machine parts, which causes damage

Removal of the under folder group and replacement with an elastic lever

Removal of under the folder group and replacement with an elastic lever
