GD X2

Elastic lever blank carriage

Correct blank positioning issues with an elastic lever blank carriage upgrade

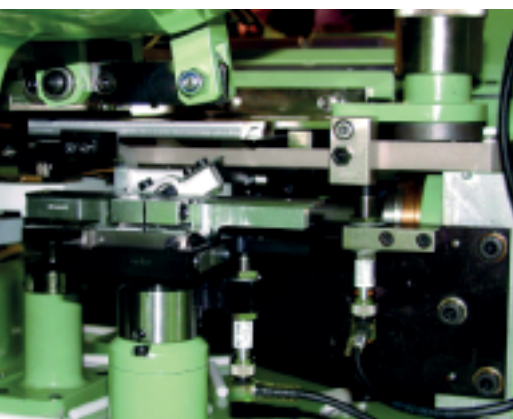
Elastic lever blank carriage which trips on overload,
stopping the machine immediately

Issue	<ul style="list-style-type: none">• Risk of machine damage• Deformed packets due to incorrect blank positioning
Consequences	<ul style="list-style-type: none">• Loss of production• Increased downtime• Quality issues
Solution	<ul style="list-style-type: none">• Removal of the blank carriage lifting group and replacement with an elastic lever• Sensor causes immediate stop after jam• Trip out plate to prevent excessive load on machine parts, which causes damage
Advantages	<ul style="list-style-type: none">• Reduced downtime• Reduced risk of machine damage• Quality improvement
Scope	Removal of the blank carriage lifting group and replacement with an elastic lever
Time required	<ul style="list-style-type: none">• Approx. machine down time: 6 hours• Total mechanical hours: 8 hours• Total electrical hours: 0 hours (local electrical support possible)
Guarantee	<ul style="list-style-type: none">• One year guarantee
