## Max-S

## Longer bolts for tipping guide

Support bolts to avoid damaging the needles in the swash plate

## Increase operational ability and decrease down time with longer bolts for the tipping guide

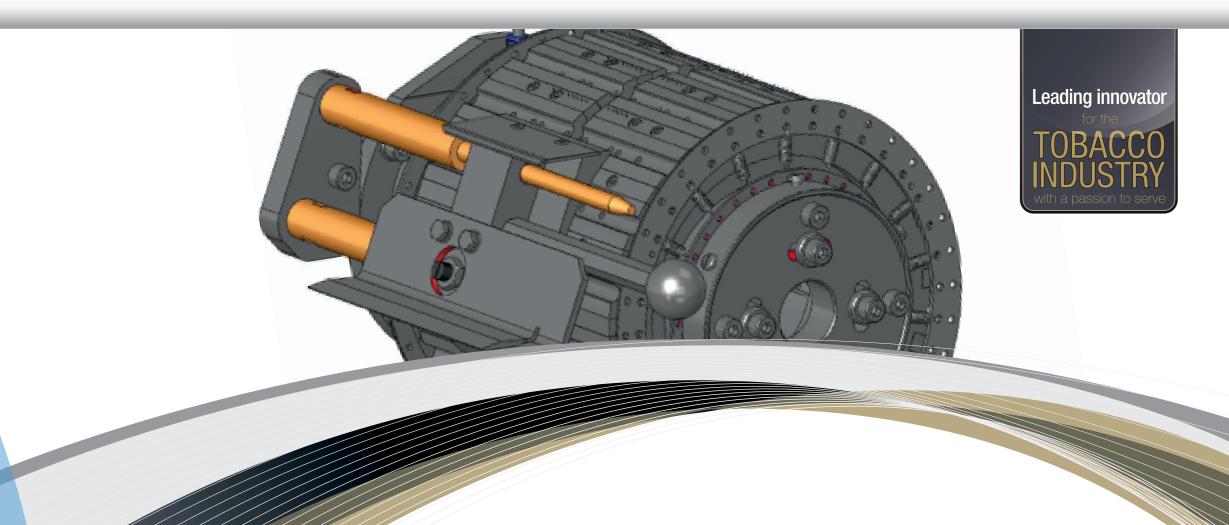
Damage to the needles in the needle drum when the tipping guide is being fitted or removed

Longer bolts for the tipping unit

Exchange of existing bolts

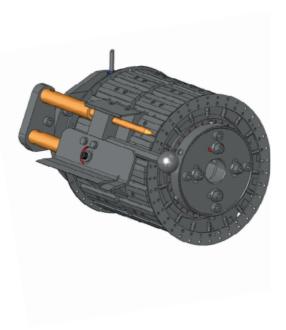
Consequences •

Down time

Increased maintenance requirements

Solution
